1.0 What is Efflorescence?

Concrete Efflorescence Fact Sheet

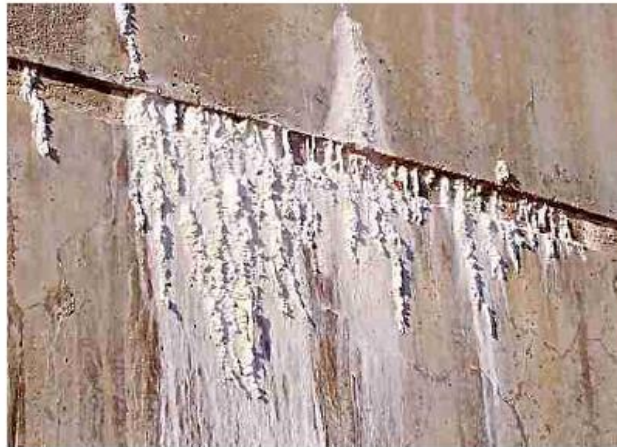
Calcium salts react with Carbon Dioxide in the air and form non soluble Calcium Carbonate. This is the hard white or yellow efflorescence seen on concrete and bricks. Because it is not soluble Calcium Carbonate cannot be washed off the surface. A mild solution of muriatic acid (Hydrochloric Acid) is normally required to remove Calcium Carbonate.

Calcium Carbonate salts

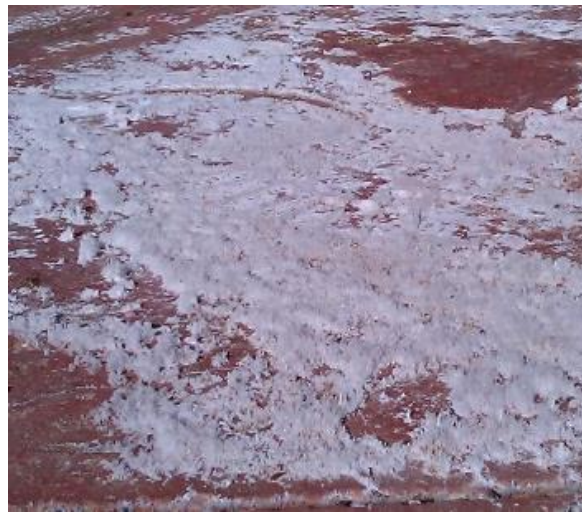
Normally fluffy white salts are water soluble like Sodium Salt crystals. This white powder is very unsightly on coloured paving or brickwork, as seen in the photographs below. Water soluble salts can be easily washed off the surface using water and a brisk scrub.

Fluffy white sodium salts

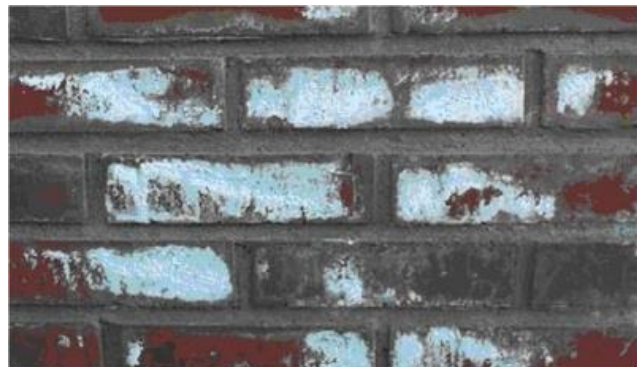
Salts on a brick wall caused by rising damp

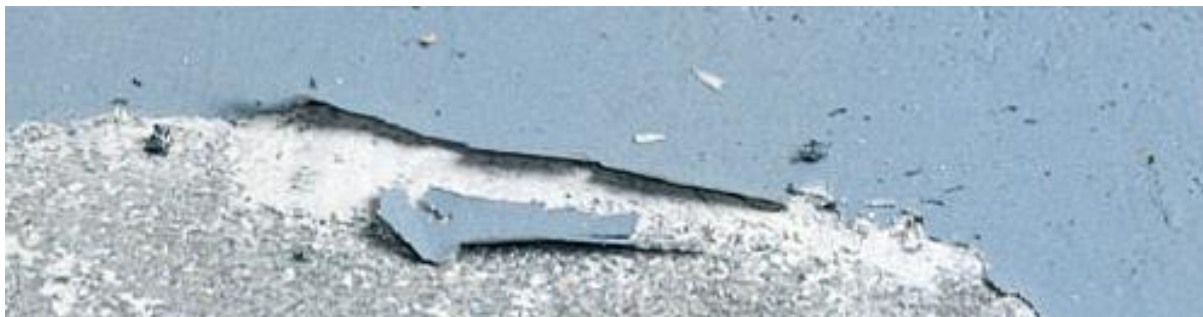
Sealer lifting due to salts underneath. Poor surface penetration and lack of adhesion very apparent due to incorrect application.

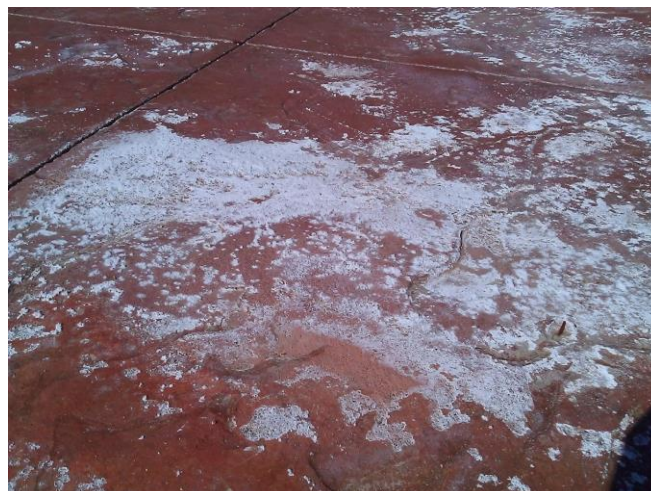
Salts on slate impression concrete where the sealer has delaminated

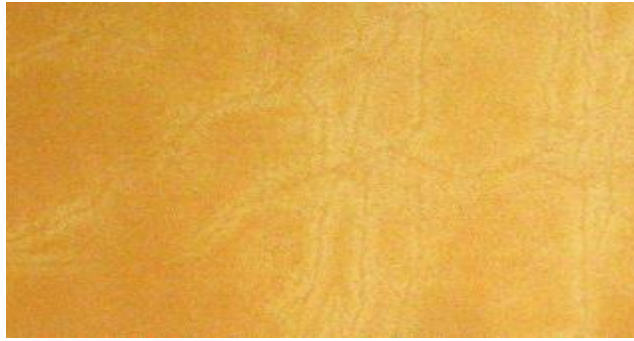
Concrete surface crazing showing colour variation due to moisture & salts

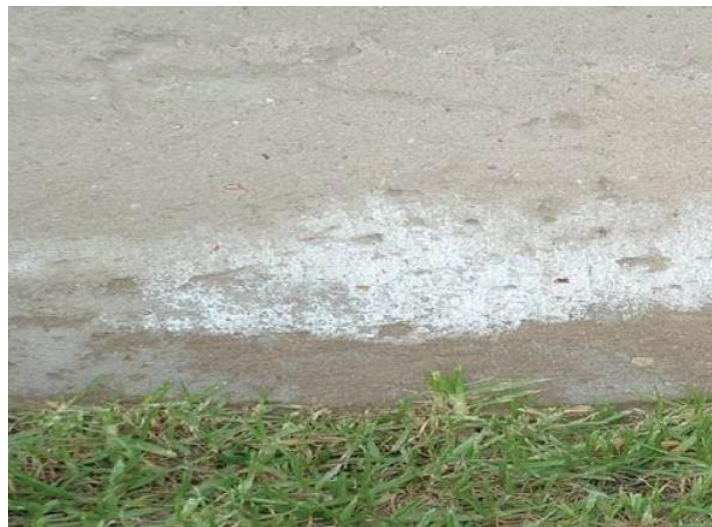
Salts on unsealed concrete adjacent to grass

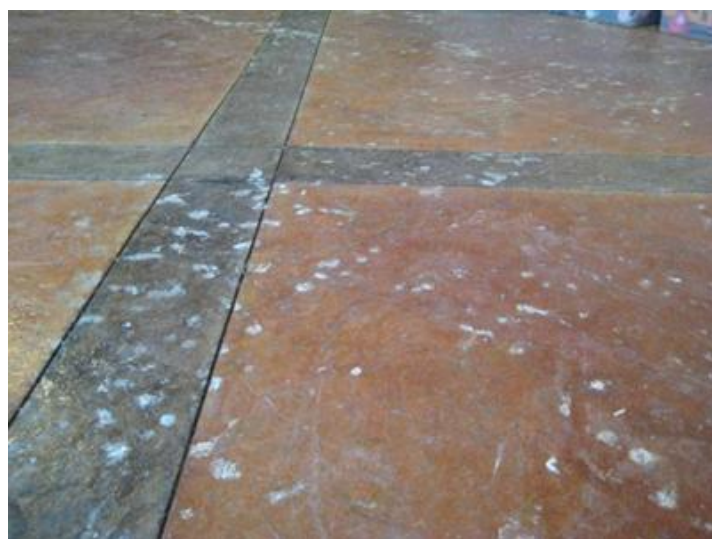
Salts patches on coloured concrete paving

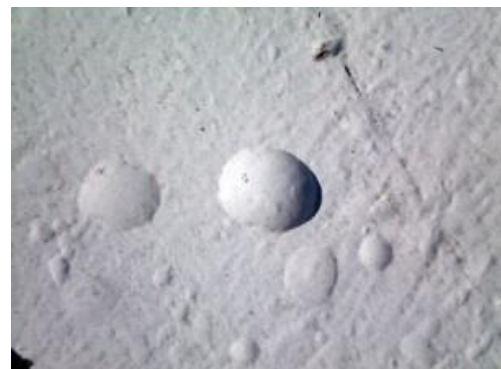
Typical osmotic blisters in Epoxy floor coating
