Fact Sheet

Concrete Efflorescence

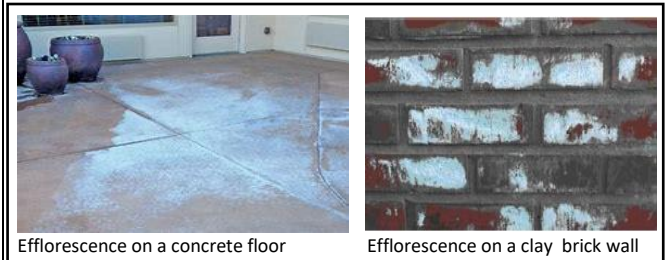
Efflorescence on a concrete floor

Efflorescence on a clay brick wall

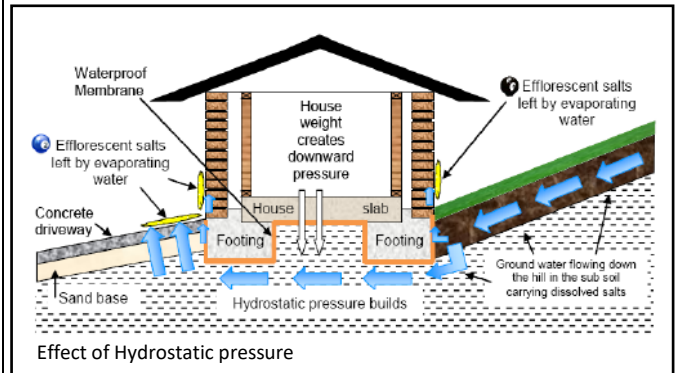
Hydrostatic pressure occurs when ground water travels under a building, the downward pressure from the building's weight forces water through the substrate to the surface.

Effect of Hydrostatic pressure

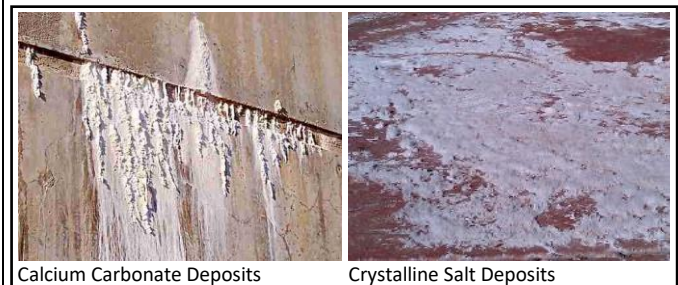
Presents as a hard white or yellow efflorescence and note easily removed.

Presents as a powdery white salt. This can generally be removed easily by washing the surface using a stiff bristled broom, water and a brisk scrub.

Calcium Carbonate Deposits

Crystalline Salt Deposits

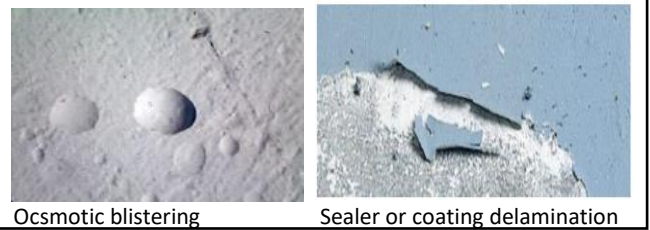
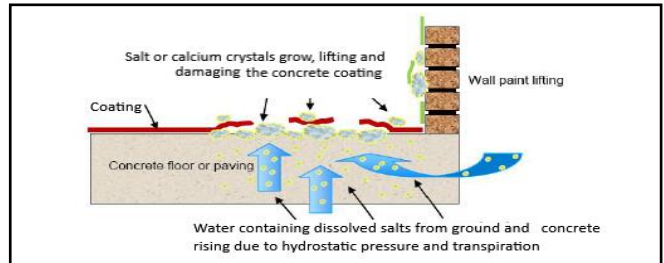
Single pack acrylic sealers are moisture vapour permeable. This means that Efflorescence salts can potentially permeate through the sealer to the surface leaving the powdery deposits on the surface.

Conversely, 2 pack coatings are typically impermeable to moisture. As the efflorescence develops under the coating, it creates osmotic blisters, ultimately causing top coat failure.
