Case Study

Trial of New Phosphate Free products

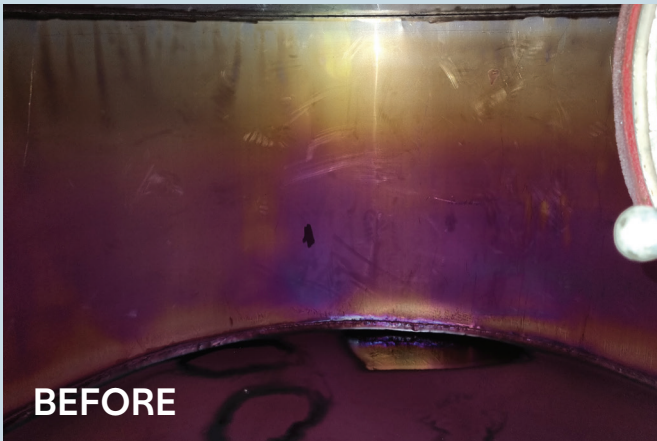
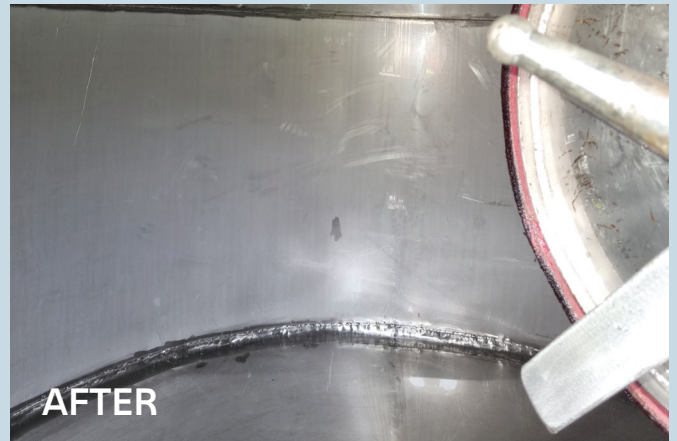
VINCIRC PHOSPHATE FREE

Images showing inside of tanks before and after using 0.52% w/v Vincirc Phosphate Free cleaning via a venturi system with 200L of cold water for 20 minutes.

A cleaning trial was conducted on 20/12/2022 in a wine manufacturing facility of 2 x 14.2kL tanks that had moderate potassium bitartrate deposits and moderate tannin staining.

Results show that both surfaces are clean, glossy, smooth, free of debris, and have no residual foam.

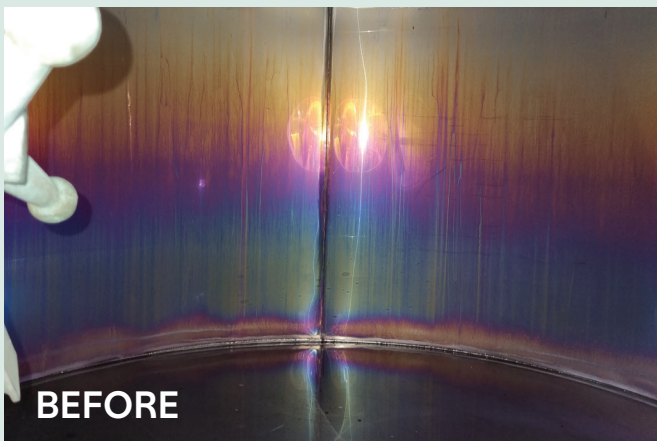
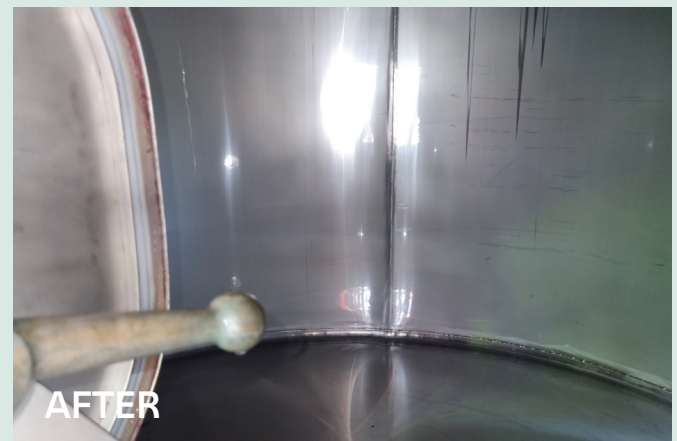
CIRCLEAN PHOSPHATE FREE

Images showing inside of tanks before and after using 0.6% v/v Circlean Phosphate Free cleaning via a venturi system with 200L of cold water for 20 minutes.
